**Failure Analysis of Chart MVE 808AF-GB Cryopreservation Tank  
Serial Number CAB2112020013**

**Pacific Fertility Center Litigation**

**Report prepared by:  
Anand David Kasbekar, Ph.D.**

**October 15, 2019**

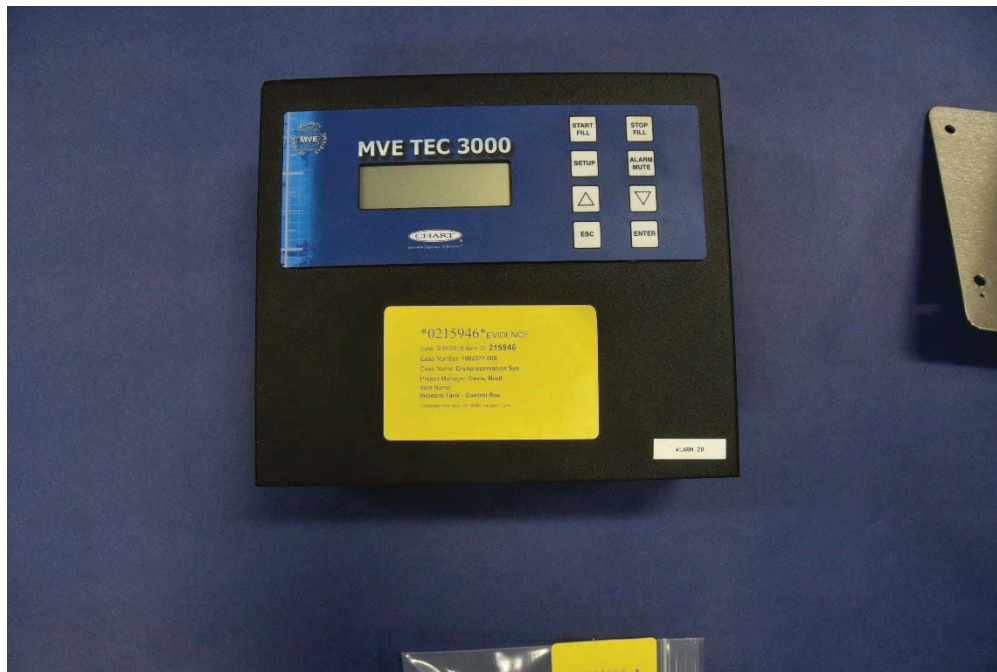
**Figure 4: Subject Chart MVE TEC 3000 Controller after removal and transport to Exponent.**

[REDACTED]<sup>17</sup> At some point after the incident, the controller, which includes an auto-fill mechanism, was removed from Tank #4. Both the tank and controller were transported from the fertility clinic to Exponent's Menlo Park Facility on March 8, 2018 (see Figure 4).

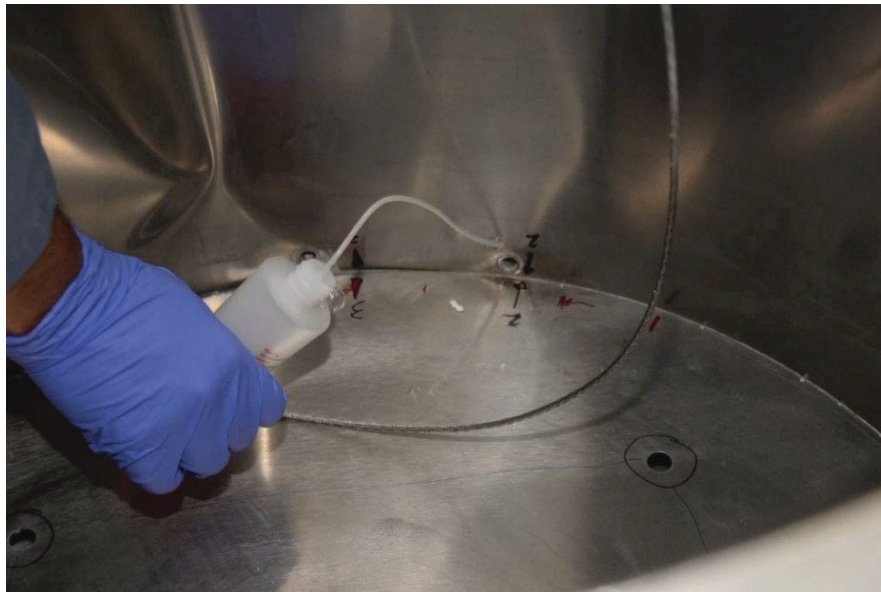
***Figure 6: Application of Swagelock Snoop® Liquid Leak Detector at the annular weld of the subject tank's interior fill port.***

A second follow-up inspection of the subject tank took place at Exponent a year later on September 30, and October 1, 2019. This second inspection involved additional photographic documentation of the subject tank, lid, vacuum port components, and associated controller. The tank was suspended by its handles in order to facilitate examination of the underside and vacuum port. Leak testing was then conducted in a reportedly similar manner to the leak testing that was done by Exponent prior to the September 25, 2018 joint inspection. A helium tank was plumbed to a modified natural gas utility meter that was equipped with pressure gauges, a temperature gauge, an Elster dial gauge to track helium flow into the subject cryogenic tank's vacuum jacket, and a Dwyer Magnehelic differential pressure gauge to monitor helium pressure within the vacuum space. The target helium pressure was 20 inches of water and the helium was plumbed into the vacuum port of the subject tank using an expansion plug. An Agilent Technologies VARI-VSPD031 VS Portable Mass Spectrometer Helium Leak Detector equipped with a Power Probe Sniffer was used to probe for leaks in the vicinity of the welded seams, fittings, and other areas both on the tank interior and exterior. Indications of leakage were found along the lower welded seam on the inside tank wall of the vacuum jacket. The most significant helium readings were detected at and within several inches of the annular weld at the edge of the lower elbow for the interior LN<sub>2</sub> fill port. Swagelock Snoop® Liquid Leak Detector was utilized to visually check for leaks within the suspect areas that were located using the helium leak detector. A clear indication of leakage (formation of bubbles) was observed and centered along the lower circumference of the welded edge of the fill port (Figures 6-8). This location was directly above the edge of the false bottom (a.k.a. tank shelf) where it meets the interior tank wall.

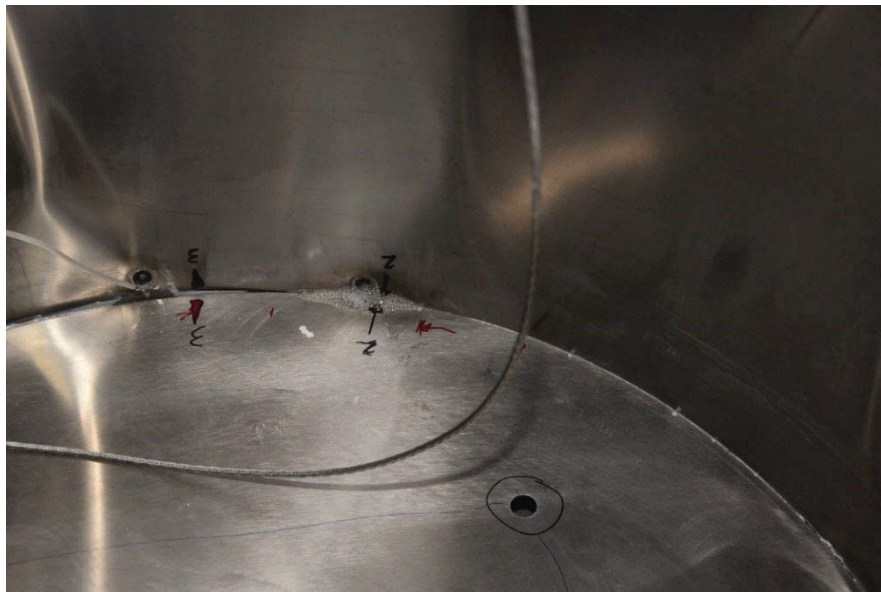
***Figure 7: Positive leak site identified by bubbles in liquid leak detector at lower region of the annular weld of the subject tank's interior fill port.***

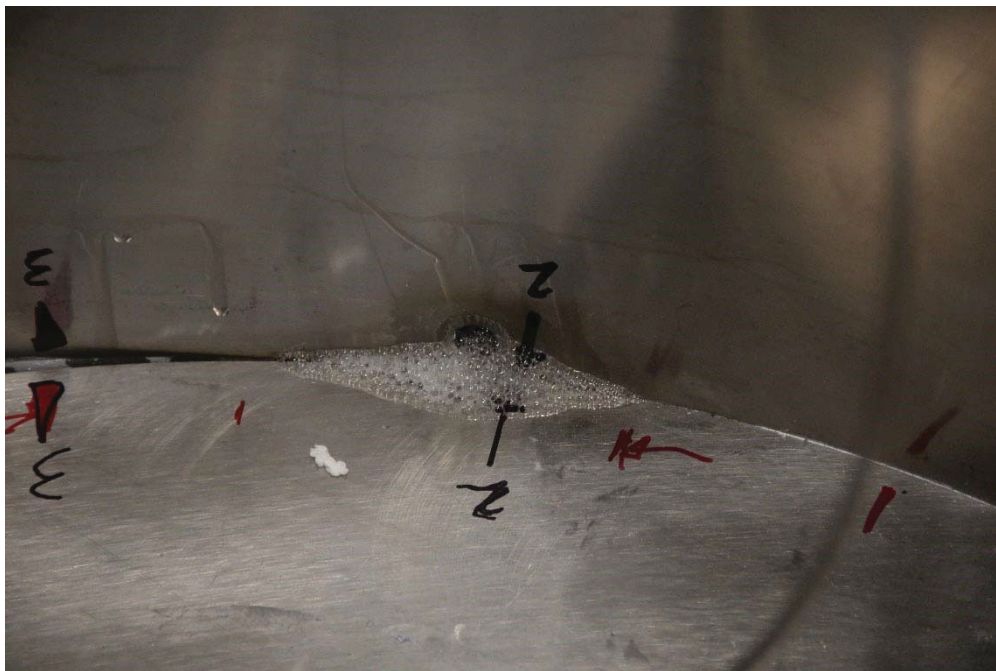
*Figure 8: Close-up of prior area shown in prior figure. Positive leak site identified by bubbles in liquid leak detector at lower region of the annular weld of the subject tank's interior fill port.*

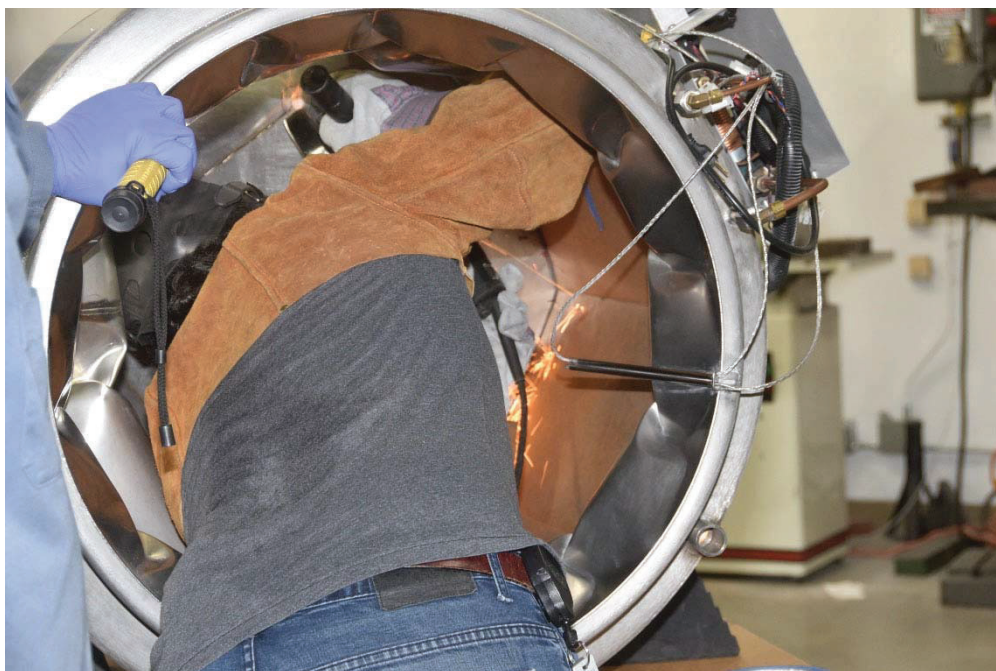
*Figure 9: Sectioning of subject tank's false bottom using abrasive cutting wheel.*

In order to gain access to the tank bottom and to further investigate the leak location, the false bottom was sectioned and removed by an Exponent representative (Figures 9-13). Sectioning was primarily accomplished using an angle grinder and abrasive cutting wheel. Care was taken not to cut or nick the interior tank wall with the cutting wheel. The thickness of the

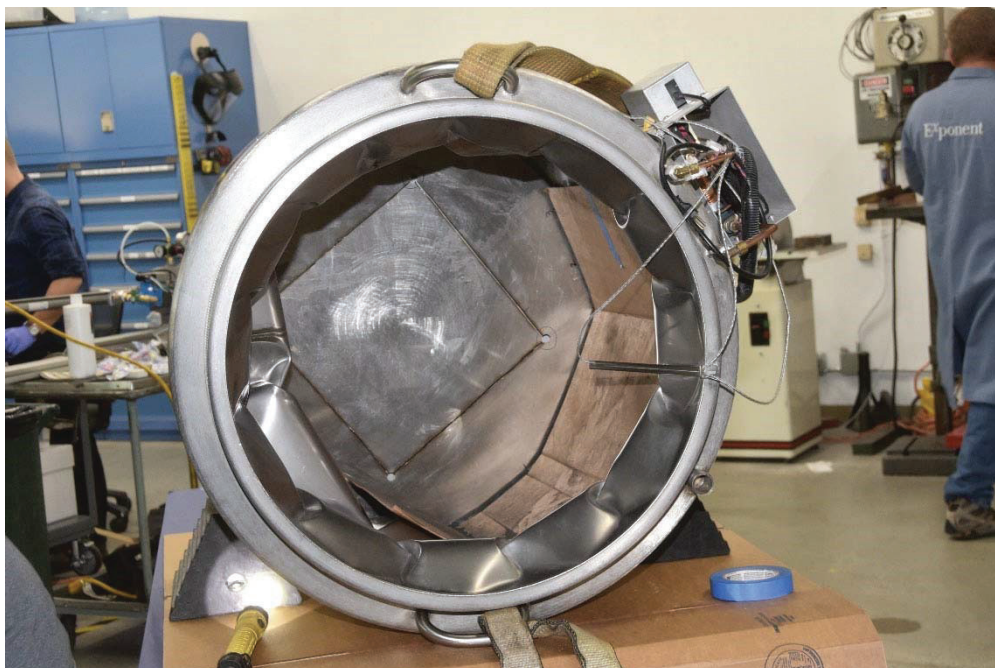
*Figure 10: Sectioning of central region of the subject tank's false bottom.*

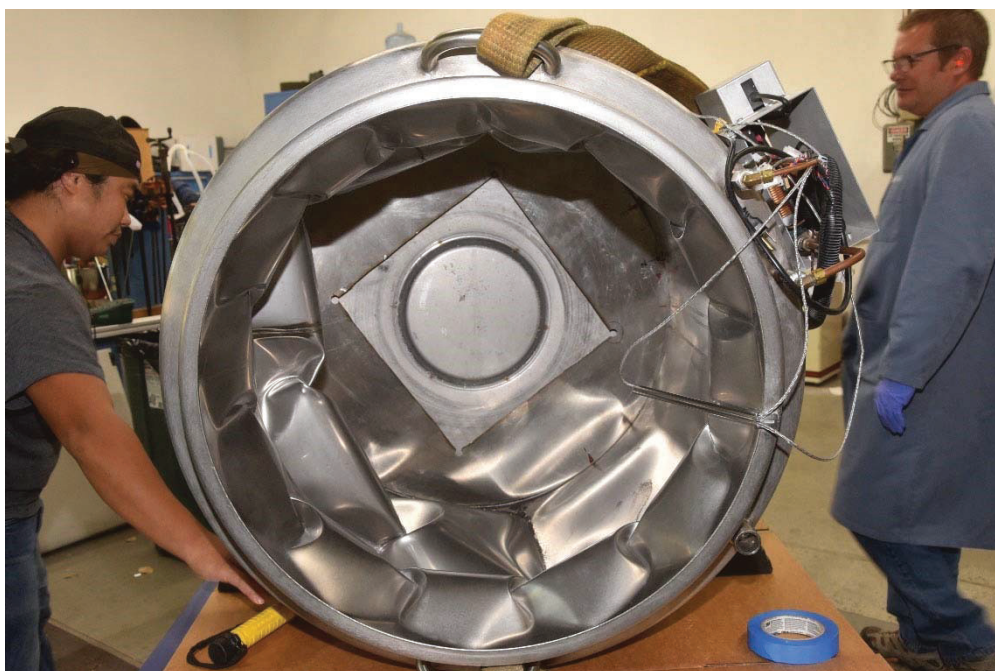
*Figure 11: Central square section removed from subject tank's false bottom revealing actual bottom of the tank.*

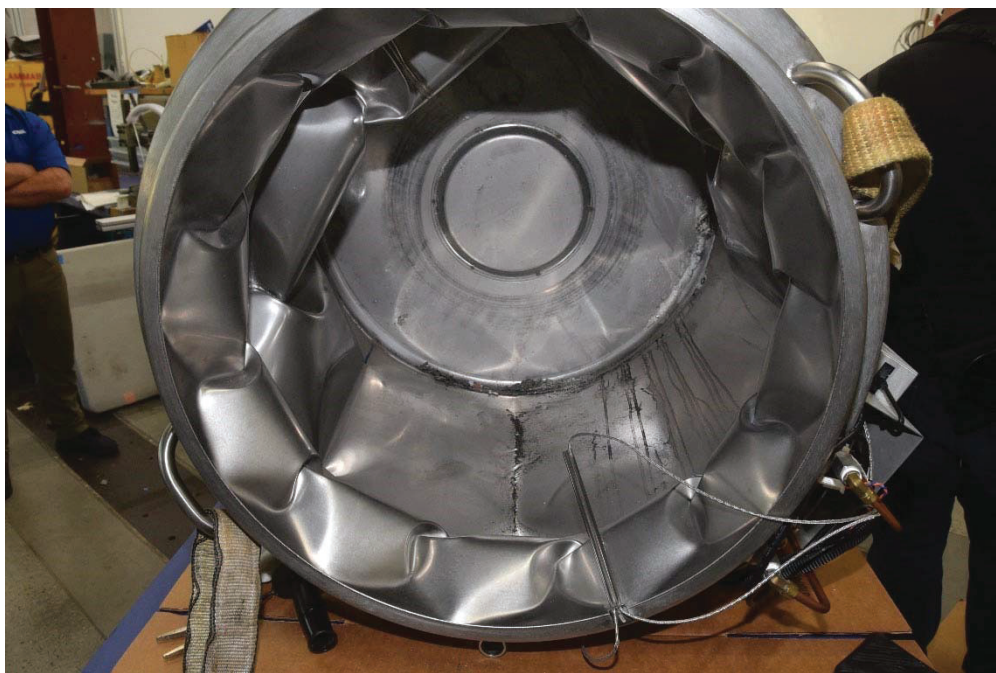
***Figure 12: Remainder of tank's false bottom removed revealing entire actual bottom of the subject tank.***

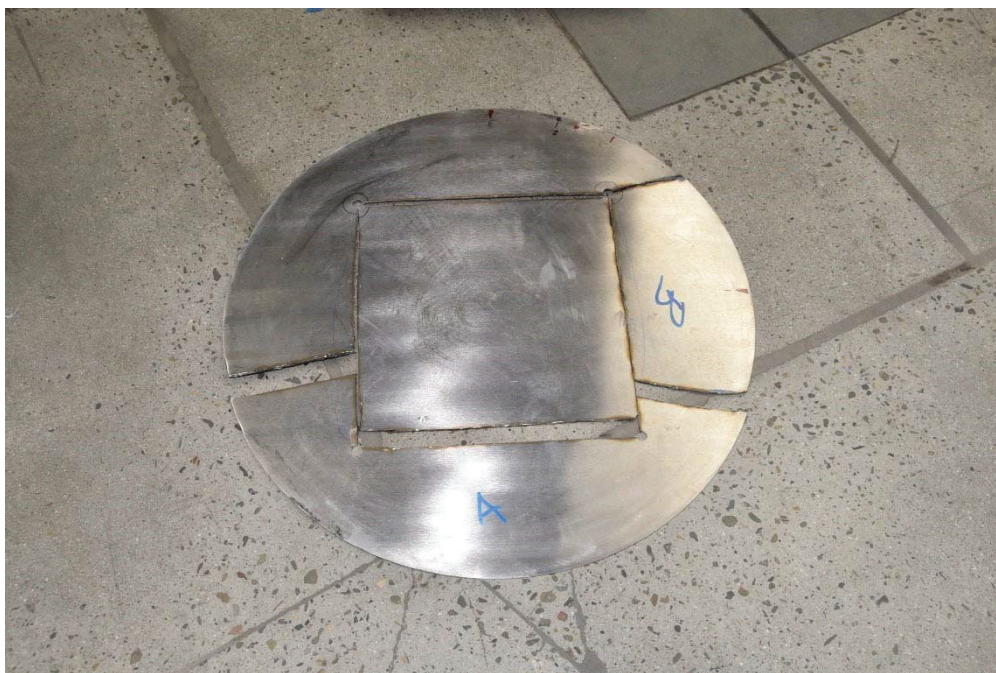
***Figure 13: Removed sections that comprise the subject tank's false bottom.***

removed false bottom measured approximately 0.11 inches

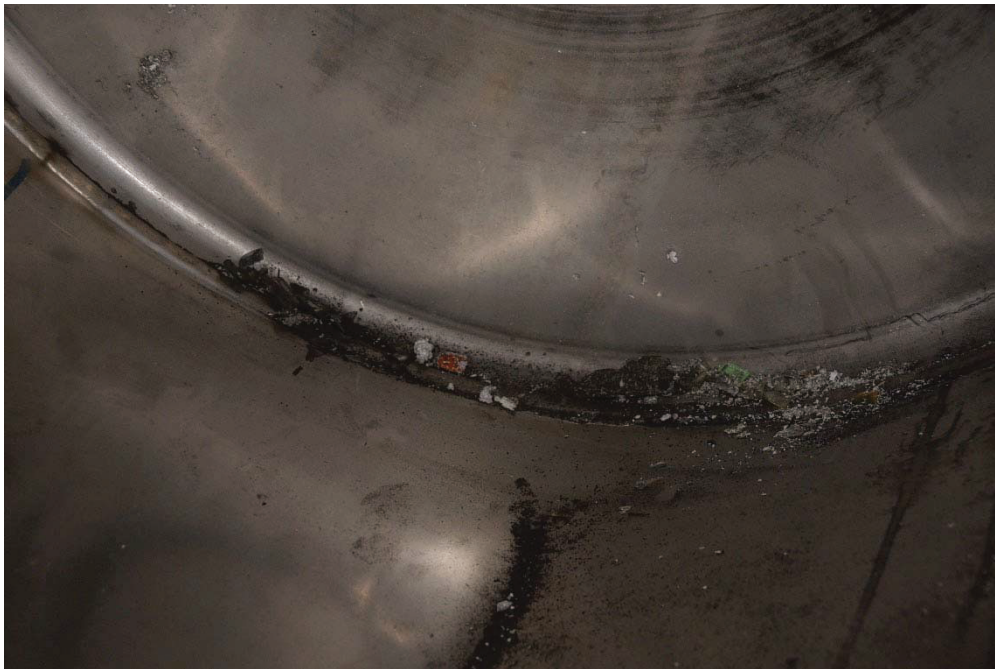
***Figure 14: Vial fragments and debris found on subject tank floor after sectioning and removal of false bottom.***

During removal of the false bottom it became apparent that fragments of broken vials were beneath this panel. The fragments and debris found on the tank floor were collected and bagged (Figures 14-15). In addition, a white residue was visible below the lower seam and generally centered around the leveling port. Three scrapings were collected to preserve this residue for future analysis if warranted (Figures 16-17).

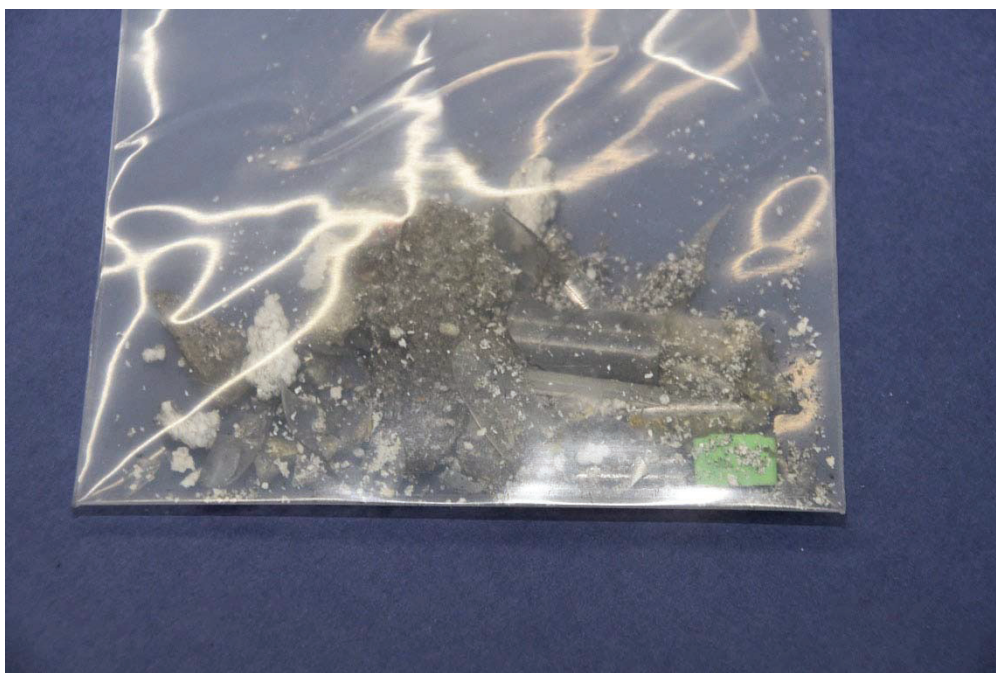
*Figure 15: Collected vial fragments and debris from subject tank floor.*

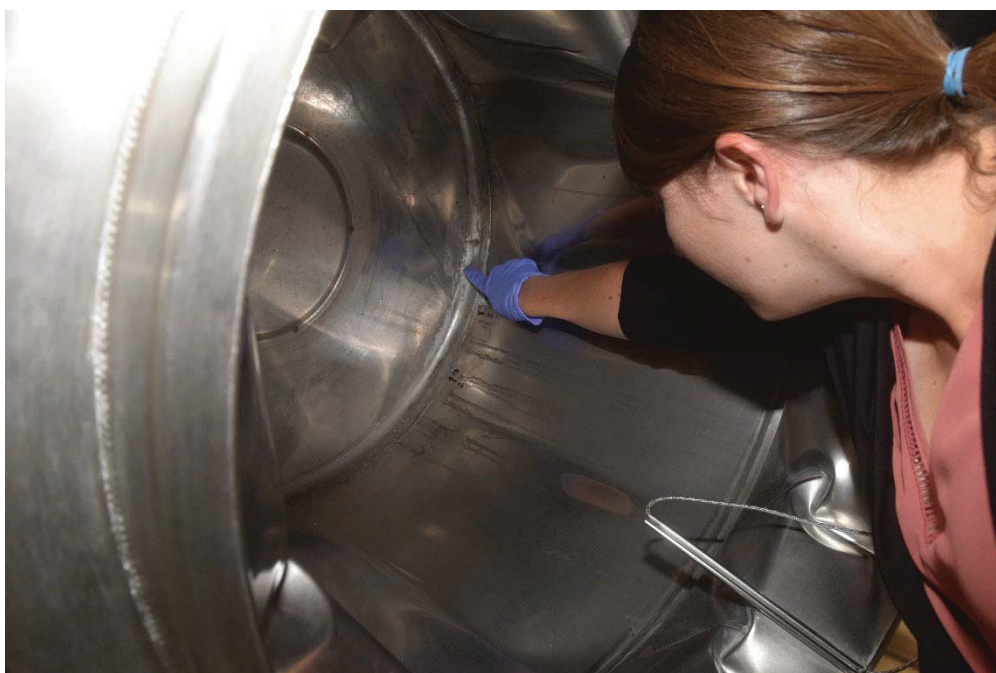
*Figure 16: White residue located below the lower seam weld of the subject tank in area of leveling port. Samples collected for potential future chemical analysis.*

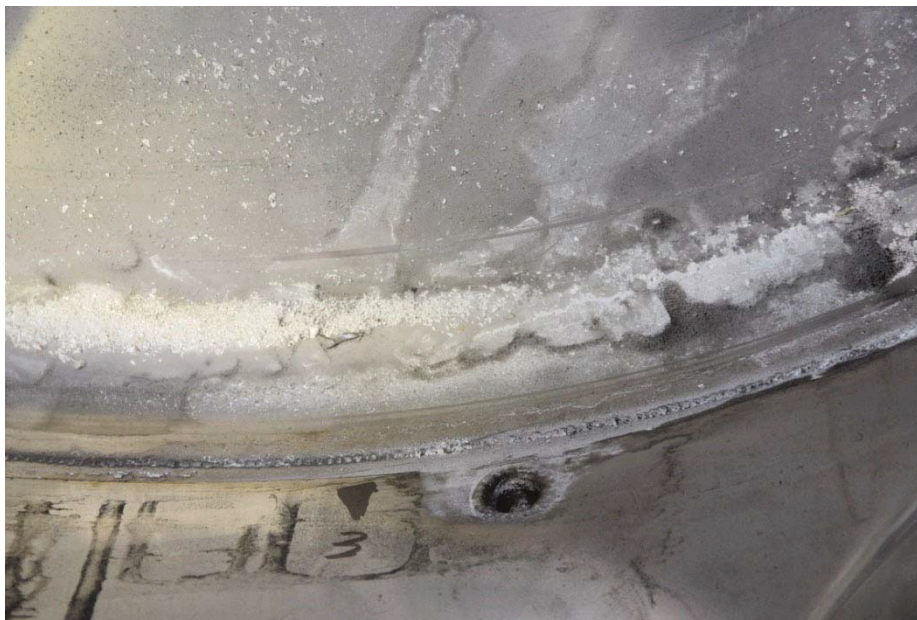
*Figure 17: Close-up of white residue shown in previous figure.*

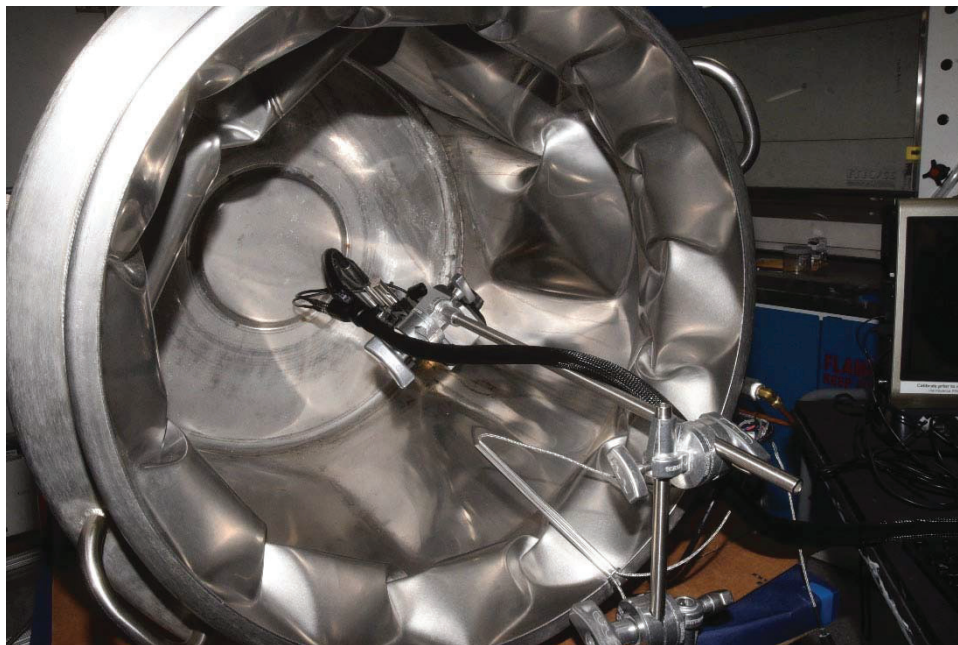
*Figure 18: Keyence Digital Microscope mounted to boom and used to evaluate weld areas in lower region of the subject tank.*

A Keyence VHX 2000 Digital Microscope fixed to a boom arm was used to more closely examine the leak area that was detected along the lower edge of the welded fill port. This microscope along with the use of a portable handheld microscope revealed a substantial crack in the weld of the fill port (Figures 18-20). This circumferential crack was clearly visible at about a 20X magnification between approximately the 4 o'clock and 8 o'clock positions. In order to further check for cracks and better evaluate the observed crack, non-destructive testing (NDT) was conducted using Magnaflux Spotcheck® liquid dye penetrant. The NDT confirmed the presence of the circumferential crack (Figures 21-22).

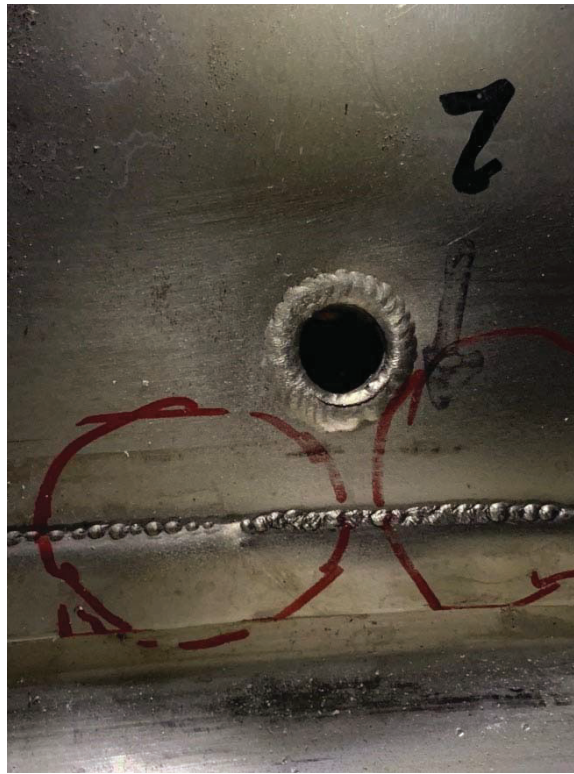
*Figure 19: Photograph of crack in annular fill port weld located above the lower seam weld.*

3. Based on the inspection of the subject failed tank to date and the available information, it appears that the cause of failure was more likely than not a breach in the interior wall of the tank. It is unlikely that this breach occurred after PFC staff removed the lid from the tank after discovering water under and around the tank on March 4, 2018. Work to date indicates that this breach originated within the circumferential weld that is intended to secure the lower elbow of the fill port to the interior tank wall. The cracked weld more likely than not allowed liquid nitrogen to enter the warmer and otherwise sealed vacuum space. The liquid nitrogen then would have flashed from its liquid state to a vapor state with a significant volume expansion which caused the vacuum jacket to become pressurized. The internal pressure that developed within the vacuum jacket resulted in deformation of the tank's interior wall. This deformation increased over a period of time after the tank lid was removed. The internal vacuum breach and the initial internal tank deformation were likely the cause of the tank lid being jammed.

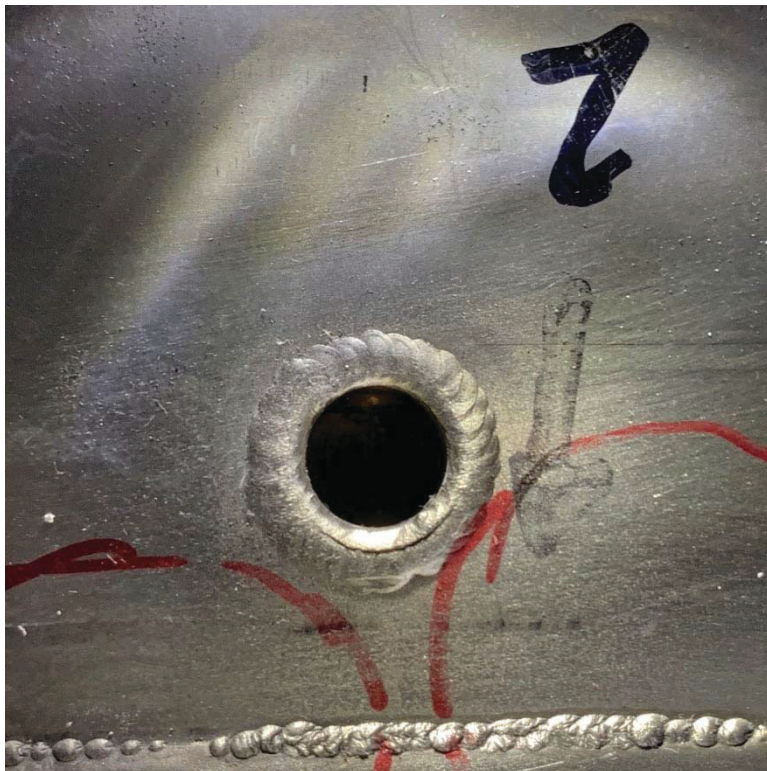
*Figure 20: Close-up of crack in annular weld of fill port shown in prior figure.*

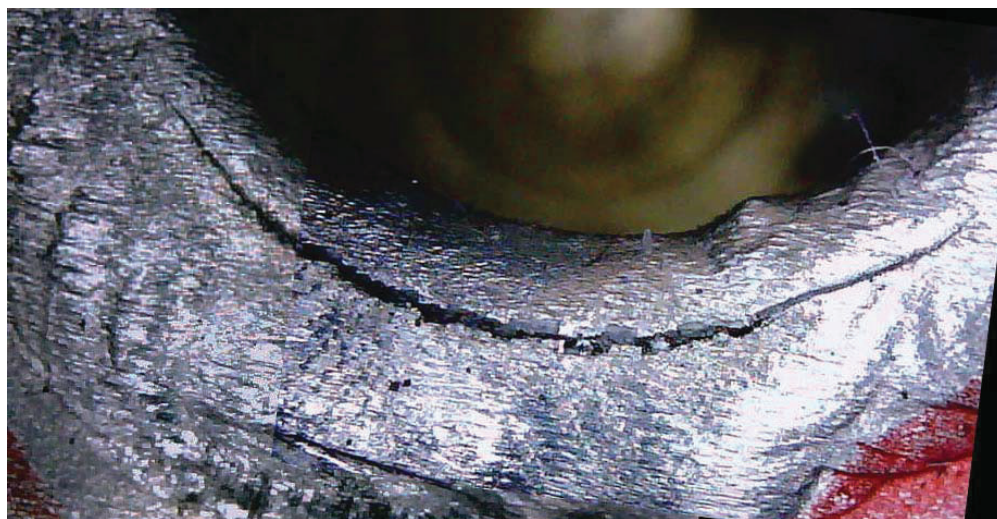
***Figure 21: Handheld digital microscope image of crack in annular weld of fill port shown in prior figure.***

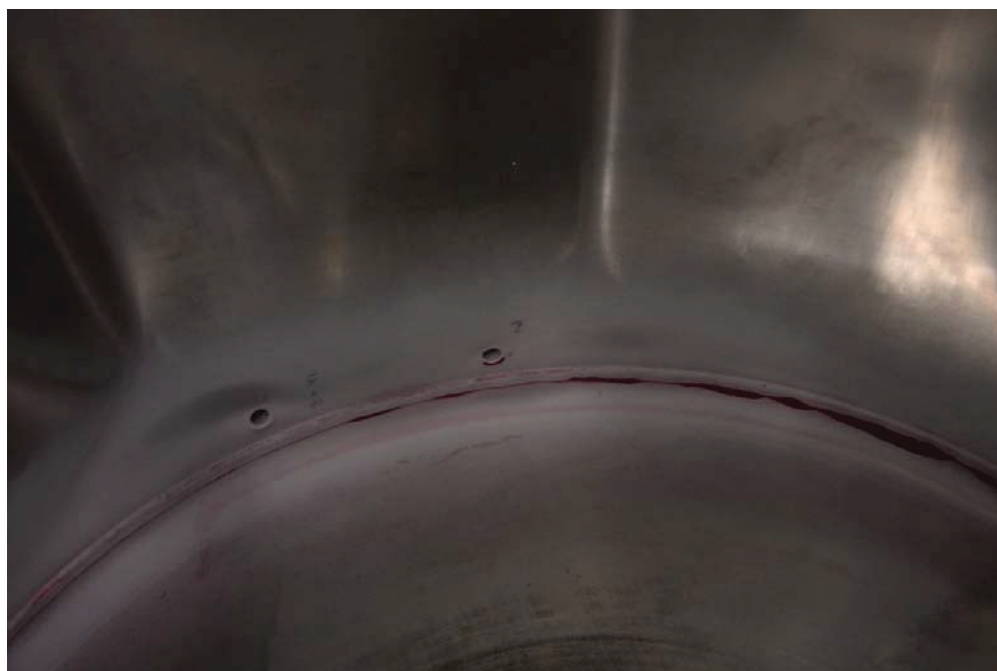
***Figure 22: Magnaflux Spotcheck liquid dye penetrant applied to lower seam weld and annular welds for the fill and level ports. Note that the annular weld for the fill port, which is the right most of the two ports, shows clear indication of cracking.***

Additional areas were noted where the red dye penetrant was visible, but most of these regions appear to be associated with the tank seam geometry under which dye was likely trapped through capillary action. There were areas along the seam weld that were revealed by this NDT method and are suspect. However, it should be noted that these areas may be a result of weld geometry or incomplete cleaning of the red dye prior to applying the developer and may not be a true indication of additional cracking. More detailed evaluation of these areas is warranted in order to confirm the presence of lower interior seam weld cracks in these suspect regions.

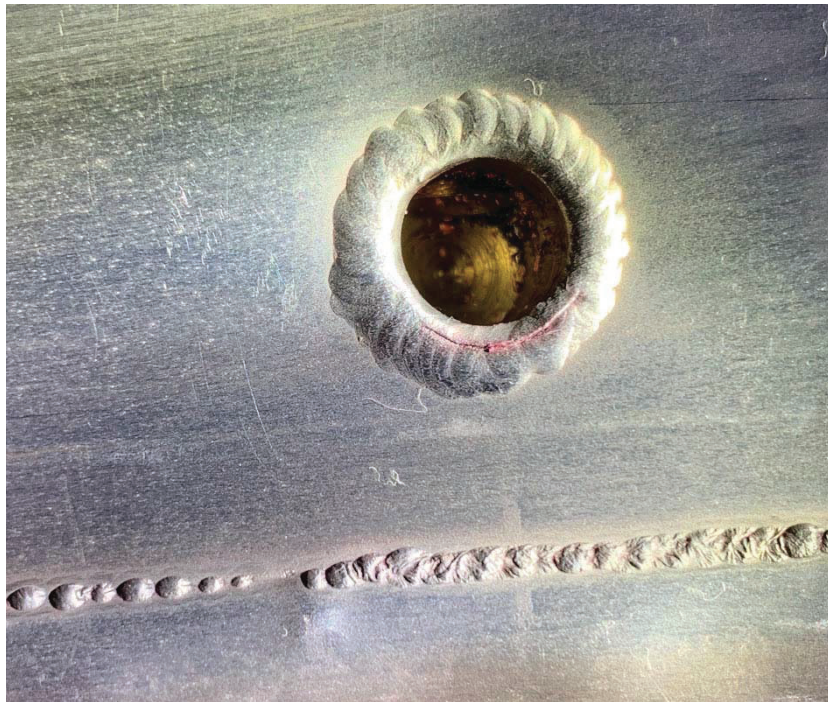
***Figure 23: Close-up of annular weld for the fill port shown in previous figure. The red line between approximately the 4 o'clock and 8 o'clock positions is a clear indication of cracking.***
